*Engineering and Industry Series*

*Volume Power Systems, Energy Markets and Renewable Energy Sources in South-Eastern Europe*

## Composite Outdoor High Voltage Insulators in Crete - 37 Years of Experience

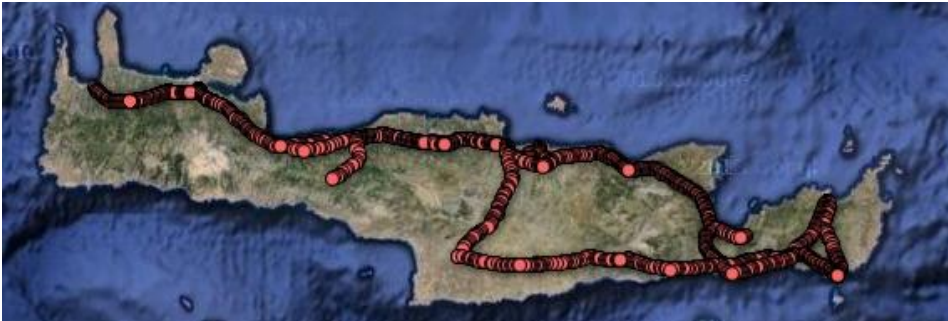
**Fig. 1. The 150kV transmission system of Crete**

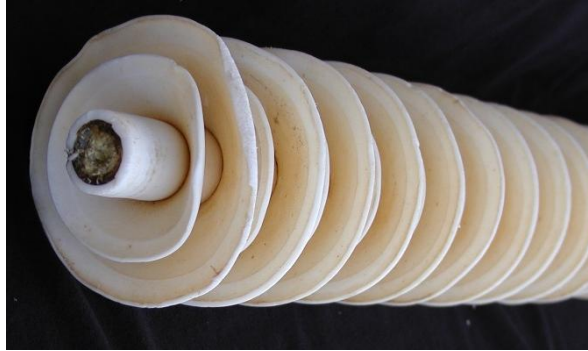
**Fig. 3. PTFE insulator destroyed due to the action of brittle fracture**

The first installation of composite high voltage insulators in Crete took place in 1979, were a number of PTFE (Teflon) insulators were installed in one transmission line, located in the north side of the island and a route from the centre to the east side, were the problem of pollution was very intense. The performance of these insulators was exceptional, as far as the problem of pollution is concerned. Throughout the time period, these insulators were in service, no maintenance remedies were taken and no pollution related flashovers were experienced. Unfortunately, they also experienced the problem of brittle fracture, which was very common for composite insulators of the first and second generation. A picture of a Teflon insulator with brittle fracture is illustrated in figure 3. The reason of the problem is known to be the corona discharges experienced and a number of pinholes created as a result. Signs of this degradation have been found in the case of Crete also and a typical example is illustrated in the picture of figure 4.

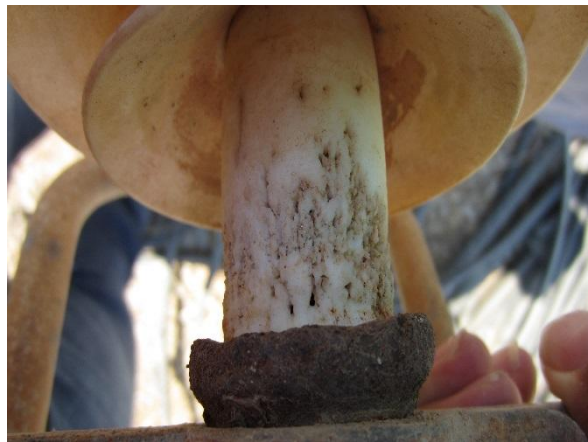
**Fig. 4. Pinholes due to corona discharges on a PTFE composite insulator**

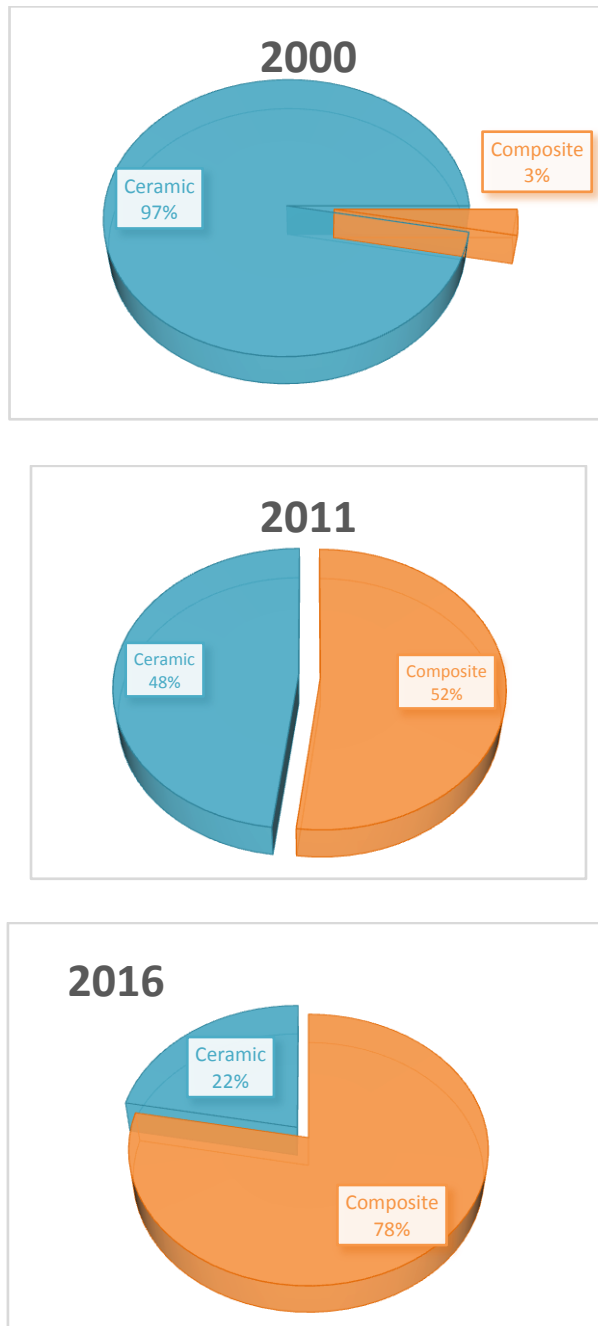
Twenty one years later, the second stage of composite insulators installation in Crete started. Today 16 years later, the majority of insulators in service in the transmission lines of Crete are composite and the remaining ceramic will be replaced in the near future. The change of the insulation map in Crete is illustrated in the pie graphs of figure 5.

**Fig. 5. Insulation map of the 150kV Transmission lines in Crete in 2000, 2011 and 2016**

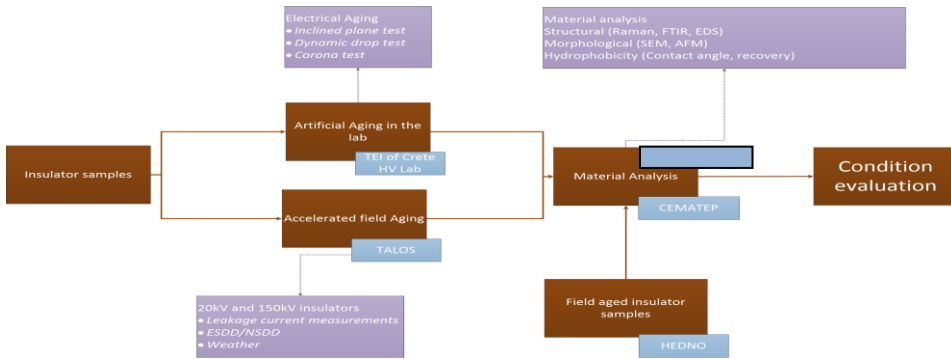
**Fig. 6. The insulators evaluation procedure and the tests performed**

In order to assess the condition of the insulators installed in Crete and considering the large number of units installed, a sampling procedure was decided, based on the insulator age and the pollution stress conditions experienced, according to Equivalent Salt Deposit Density (ESDD) measurements, performed by HEDNO since the 1980s. The insulators selected are included in table 1. Then the evaluation procedure included laboratory and field electrical aging, with the later performed at TALOS Test Station and a number of physical chemical and material analysis techniques, in order to draw the most possible reliable conclusions about the insulator condition. The evaluation procedure and the tests performed are illustrated in the diagram of figure 6.

The test results revealed that although the insulators were in service for many years, the experienced performance is satisfactory, with the exception of certain cases where the base polymer was not Silicone Rubber. In the latter case, the loss of hydrophobicity is evident and certainly an issue of concern. However, a very limited number of non-silicone composite insulators has been installed, mainly for testing and evaluation and therefore this is not an issue of concern, since they will be replaced. In the other cases however, although the results are satisfactory, evident degradation has been detected and therefore further testing is required.
